# Manhole Inspection Summary

Manhole # S27M\_\_017MH

Insp Date: **5/7/08 11:45 AM**

**Location** Address: **512 Callender St**

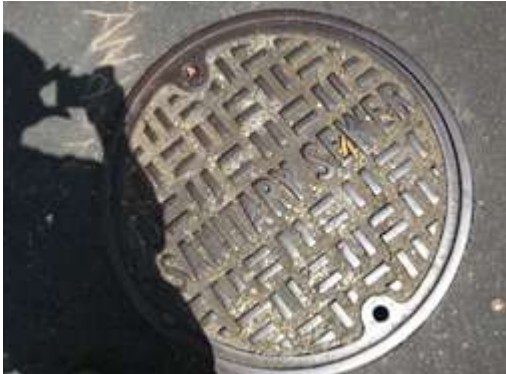
Cover View

Type: **Sanitary** Condition: **Sound** Cover Material: **Cast Iron**

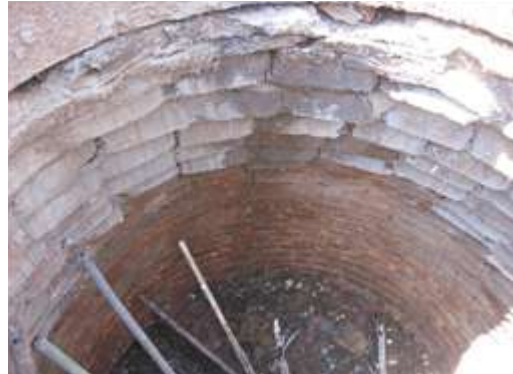
Defect 4

Condition: ☐ Sound ☐ Cracked ☐ Root Intrusion ☒ Loose Brick ☒ Deteriorated

Infiltration: ☐ None ☐ Joint ☐ Cracks ☒ Mortar ☐ Roots ☐ Wall

Condition: ☐ Sound ☐ Cracked ☐ Root Intrusion ☐ Loose Brick ☒ Deteriorated

Infiltration: ☐ None ☐ Joint ☐ Cracks ☒ Mortar ☐ Roots ☒ Wall

chimney cond deteriorated, chimney mortar, chimney flow wall, corbel mortar, corbel flow wall, corbel cond deteriorated,

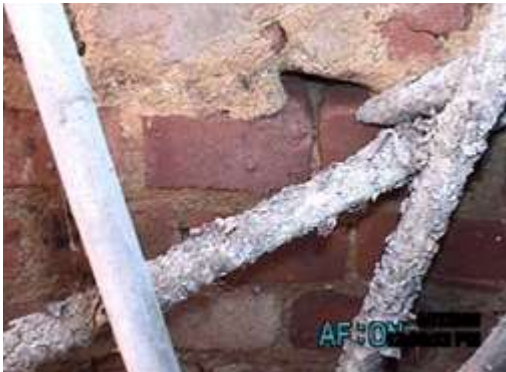
Defect 3

Condition: ☐ Sound ☐ Cracked ☐ Root Intrusion ☐ Deteriorated ☐ Leaks ☒ Debris

bench cond debris

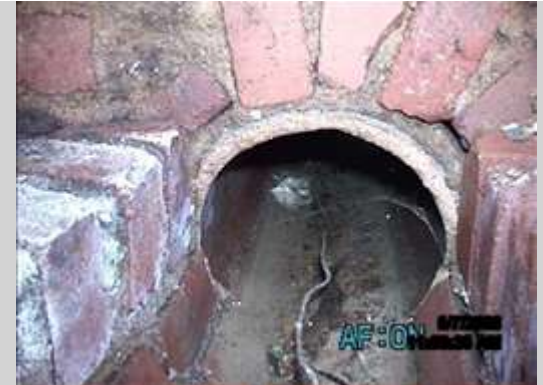
12 O'Clock Outflow

8 in. Circular Gravity Sewer  
Pipe Out @ 12 O'Clock

Pipe Height: **8.4** (in.) Rod and Bar (Angled)  
Pipe Material: **Clay** ☐ Pipe Lined  
Invert Depth: **6.55** (ft.) Flow Characteristics: **Fast**  
Deposits: ☒ None ☐ Mud ☐ Sludge ☐ Debris ☐ Grease  
Silt Depth: **0** (in.) Deposits Extent:  
Infiltration: **None** Pipe Seal Cond: **Sound**

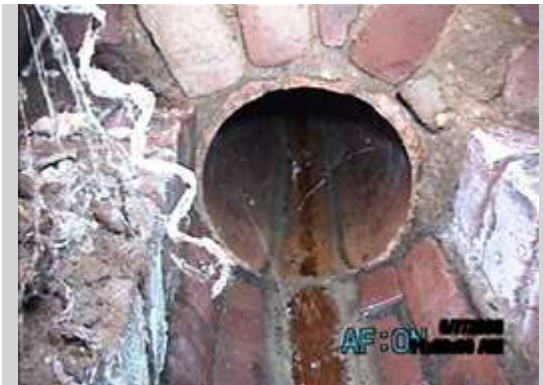
9 O'Clock Inflow

8 in. Circular Gravity Sewer  
Pipe In @ 9 O'Clock

Pipe Height: **8.4** (in.) Rod and Bar (Angled)  
Pipe Material: **Clay** ☐ Pipe Lined  
Invert Depth: **6.43** (ft.) Flow Characteristics: **Fast**  
Deposits: ☒ None ☐ Mud ☐ Sludge ☐ Debris ☐ Grease  
Silt Depth: **0** (in.) Deposits Extent:  
Infiltration: **None** Pipe Seal Cond: **Sound**
